# National Transportation Safety Board

## Safety Recommendation

**Date:** May 18, 2012

**In reply refer to:** A-12-18 through -20

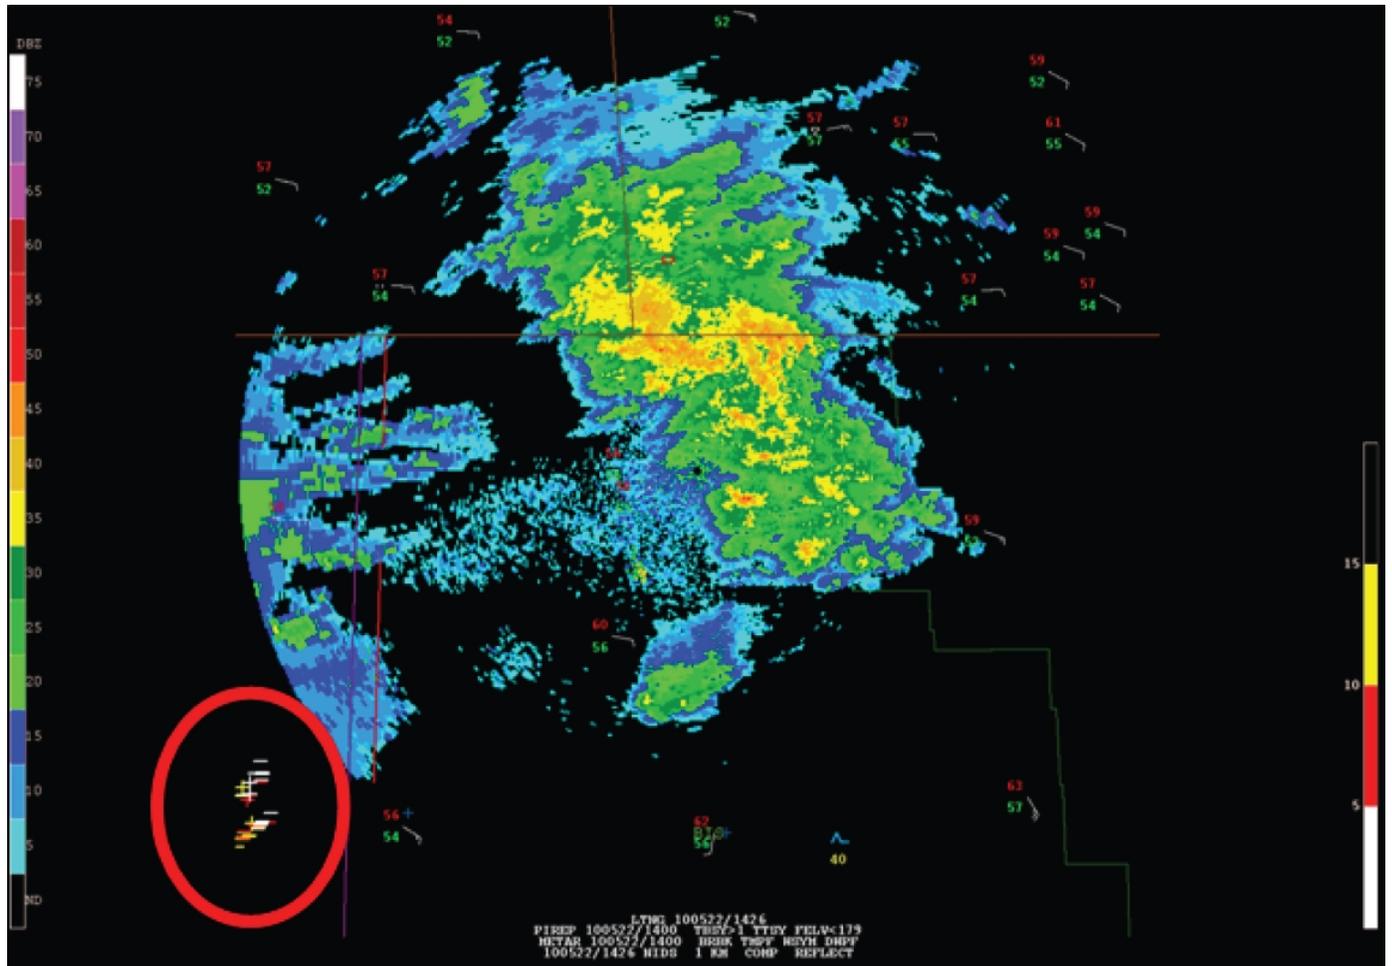
thunderstorm identification in regions of the National Airspace System where weather radar data are unavailable, such as parts of the Gulf of Mexico and portions of the western continental United States (see figure 1). In addition, lightning information is an important supplement to weather radar data because it can identify regions of airspace conducive to hazardous events even where precipitation returns from weather radar do not appear to be significant. For example, in 2002, a Chautauqua Airlines Embraer 145 regional jet descending through 13,000 feet near Windsor Locks, Connecticut, was struck by lightning,<sup>4</sup> resulting in two of its four elevator cables being severed. No thunderstorm-related precipitation had been detected by weather radar in the vicinity of the airplane.

**Figure 1.** Image depicting weather radar coverage from Minot, North Dakota, as well as lightning data (“+” and “-” symbols). The red circle highlights lightning data outside of weather radar coverage.<sup>5</sup>

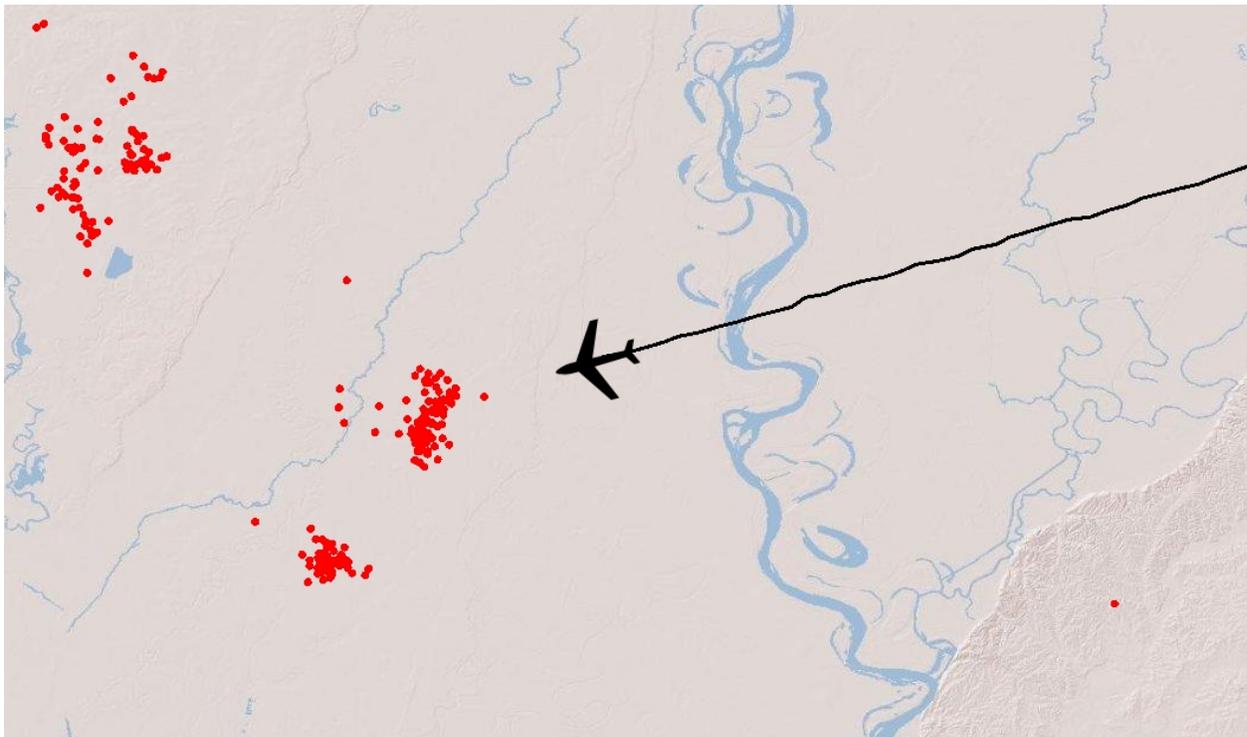
An NTSB review of recorded air traffic control (ATC) weather information along the airplane’s flightpath showed that an area of extreme intensity precipitation returns existed at the accident location and had been present for at least 15 minutes before the airplane encountered

severe turbulence. Review of ATC communications revealed that the air traffic controllers handling the flight did not advise the pilot of the precipitation ahead, as required by Federal Aviation Administration (FAA) Order 7110.65, *Air Traffic Control*.<sup>9</sup> When interviewed, the controllers handling flight 3224 stated that their displays did not show any precipitation at the accident location.<sup>10</sup>

An NTSB meteorologist also reviewed commercially available archived lightning data (from the Earth Networks Total Lightning Network [ENTLN]<sup>11</sup>) for the area and noted that substantial lightning activity had been recorded at the accident location. Figure 2 shows the airplane's position immediately before the accident, along with the locations of lightning strokes detected during the preceding 20 minutes. The lightning detected by the ENTLN was a strong indication of the presence of a thunderstorm immediately in front of the airplane. The captain stated in postaccident interviews that if he had been aware that there was a thunderstorm ahead, he would have asked ATC for a course change because American Eagle's policy instructed pilots to avoid thunderstorms by 20 miles.

**Figure 2.** American Eagle flight 3324 flightpath (black line) immediately before the accident 1751 central daylight time. Red dots indicate total lightning detected between 1731 and 1750.

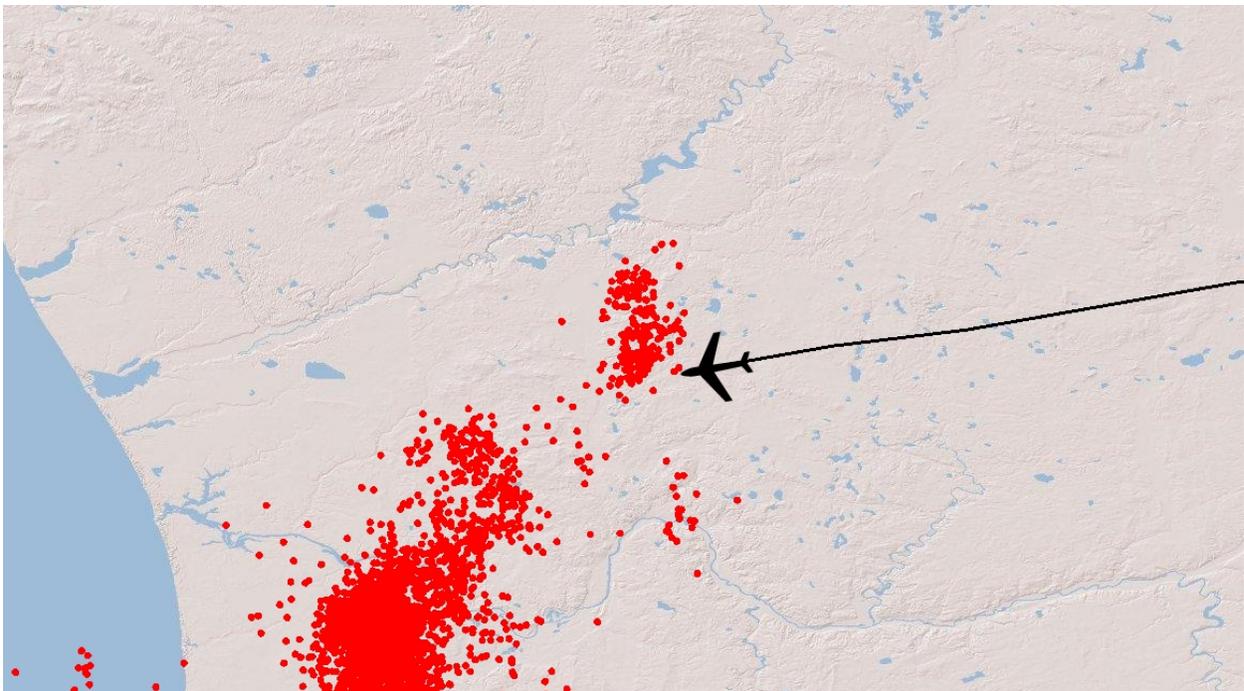
On July 1, 2011, about 1230 central daylight time, Pinnacle Airlines flight 4018, a Bombardier CRJ-200, encountered hail at flight level 200 while en route from Detroit, Michigan, to Milwaukee, Wisconsin. The airplane incurred impact damage to the radome, wing leading edges, and engine inlets that was not discovered until inspection after the airplane landed in Milwaukee. Because the damage to the airplane did not meet the regulatory standard for an accident or incident, a formal NTSB investigation did not occur, but NTSB meteorology and ATC investigators reviewed the circumstances of the event.

Plots of the airplane's position along with lightning data (see figure 3) indicated that the airplane penetrated an area of dense lightning activity. Analysis of ground-based weather radar data indicated that a convective cell collocated with the lightning activity may have contained hail up to 2 inches in diameter. Figure 3 depicts the flightpath of flight 4018 immediately before the hail encounter and shows that lightning activity was present during the previous 20 minutes at the event location. Review of ATC communications indicated that the crew was not advised of any detected precipitation, and, according to information provided by Pinnacle, the flight crew did not recall seeing any precipitation on their airborne radar display.

**Figure 3.** Pinnacle Airlines flight 4018 flightpath (black line) at 1226 central daylight time. Red dots indicate total lightning detected between 1206 and 1225 central daylight time.

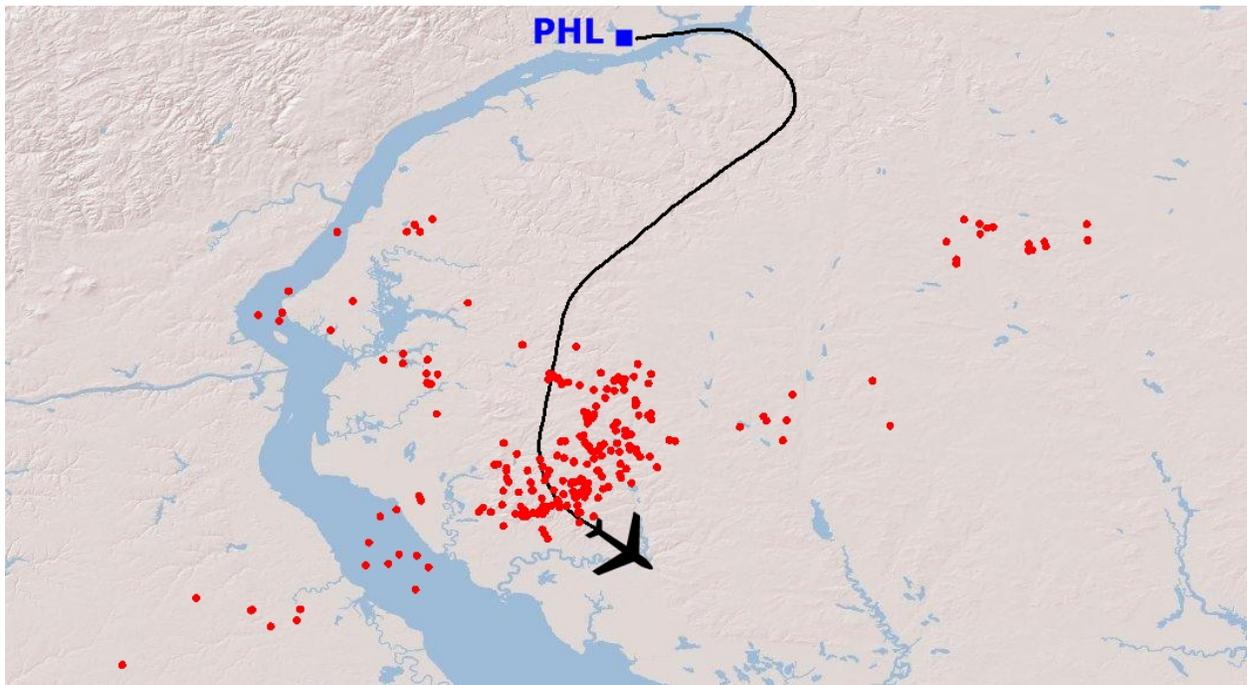
emergency, and diverted to Baltimore, Maryland, where the airplane landed without further incident. At the time of the incident, the flight was under control of the Washington ARTCC. When the pilot first contacted the center, the controller advised of moderate rain and turbulence along the airplane's route. About 3 minutes later, the pilot reported that the airplane had sustained a lightning strike and requested to return to Philadelphia "with priority," later changing the destination to Baltimore. The pilot added that the airspace the flight had just traversed contained "...moderate to possible severe..." turbulence, with multiple cloud-to-cloud lightning strokes. Figure 4 depicts the position of the airplane about the time that the pilot reported the lightning strike, along with the locations of lightning strokes detected in the area during the 15 minutes before the event.

**Figure 4.** US Airways flight 1209 flightpath (black line) about 1015 eastern daylight time. Red dots indicate total lightning detected between 1000 and 1015.

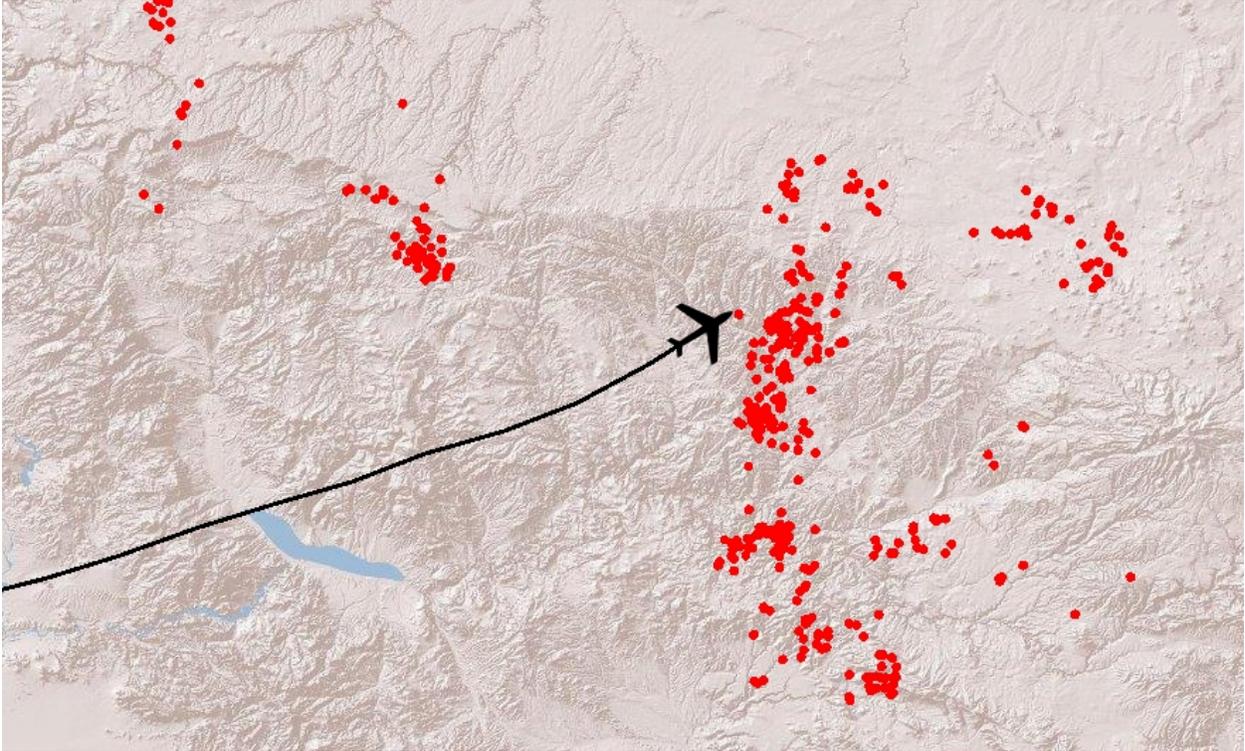
On August 18, 2011, about 1442 mountain daylight time, the flight crew of American Airlines flight 1894, a McDonnell-Douglas MD-83 en route from Phoenix, Arizona, to Dallas/Fort Worth, Texas, declared an emergency after encountering severe icing conditions at 33,000 feet near Show Low, Arizona. The crew diverted to Albuquerque, New Mexico, where the airplane landed without further incident. Severe icing events at these altitudes are rare and are normally associated with convective activity that can be readily detected by ground-based weather radar. Review of radar data recorded along the airplane's flightpath suggested the presence of convective activity in the area but only moderate precipitation returns at the location of the reported icing. However, as shown in figure 5, there was significant lightning detected in the area of the incident for at least 20 minutes before. If this information had been available to the crew, it would have alerted the pilots to potential hazards associated with convective activity well before they entered the area.

**Figure 5.** American Airlines flight 1894 flightpath (black line) at 1540 mountain daylight time. Red dots indicate total lightning detected between 1520 and 1539.

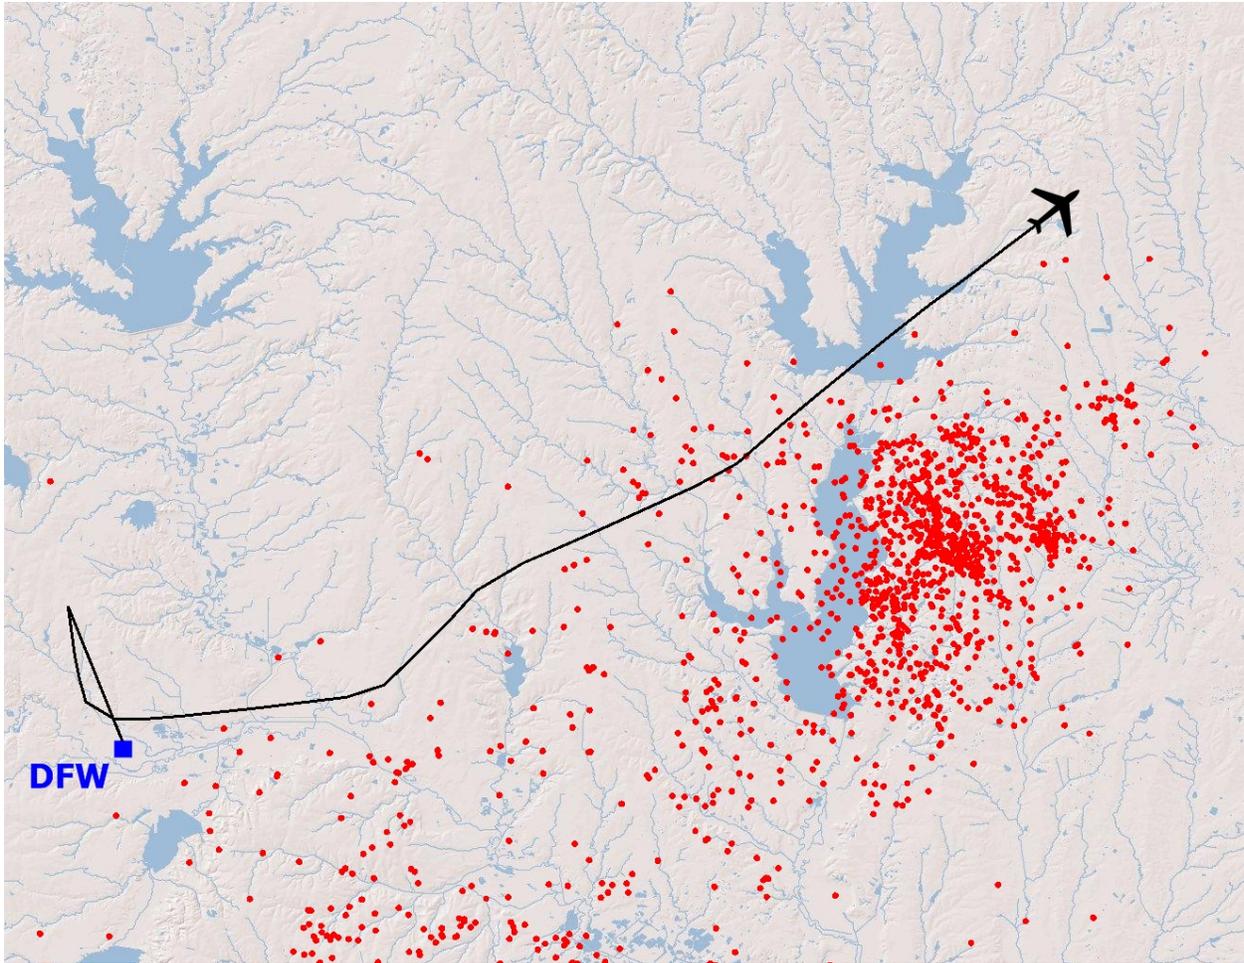
On January 24, 2012, about 1927 central standard time, the flight crew of American Eagle flight 3376, an Embraer 145 regional jet en route from Dallas/Fort Worth, Texas, to Madison, Wisconsin, declared an emergency after sustaining a lightning strike at about 17,500 feet near Farmersville, Texas. The crew immediately requested to divert to Little Rock, Arkansas, where the airplane landed without further incident. Review of weather radar data recorded along the airplane's flightpath showed convective activity in the immediate region; however, the aircraft had not penetrated any area of extreme precipitation returns. Although the aircraft successfully avoided the most dense area of lightning, significant lightning was detected along the aircraft's actual flightpath for at least 15 minutes before the emergency declaration (see figure 6). During postincident interviews, the controllers involved in the incident stated that the ability to depict lightning data on ATC displays would be useful in assisting pilots to avoid areas of hazardous weather.

**Figure 6.** American Eagle flight 3376 flightpath (black line) at 1927 central daylight time. Red dots indicate total lightning detected between 1912 and 1927.
